-RESEARCH ARTICLE-

Analytical Study on the Effect of Corrosion to the Construction Performance

Mustafa Koçer^{1*}, Murat Öztürk¹, Ahmet Raif Boğa²

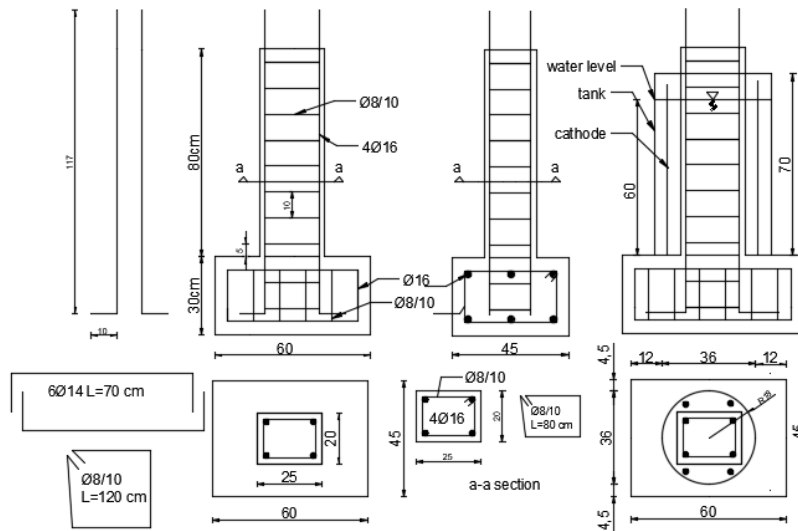
The details of the column specimen produced are shown in Figure 1. The column has a rectangular cross section and the cross-sectional dimensions are 20cm × 25cm. The height of the column is 80 cm and is supported by a foundation pier with dimensions of 60cm × 45cm × 30cm. 4Φ16 longitudinal reinforcement and Φ8/10cm transverse reinforcement are used in the column.

Figure 1. Specimen Detail

In contrast to the widespread use of stirrups, it has been no densification. The footing is reinforced with $\Phi 8/10$ cm stirrups as shear reinforcement and the upper and lower bending reinforcement $3\Phi 16$. The concrete cover of the column is 2 cm and the concrete cover of the foundation foot is 5 cm. The sample produced in Figure 2a is shown before concrete casting. Figure 2b shows the application to prevent the effects to the footing reinforcement of the electrical current. The parts of the column longitudinal reinforcements within the foundation were insulated with epoxy resin and the base surface was bitumen to prevent the penetration of NaCl ions into the base (Figure 2c).

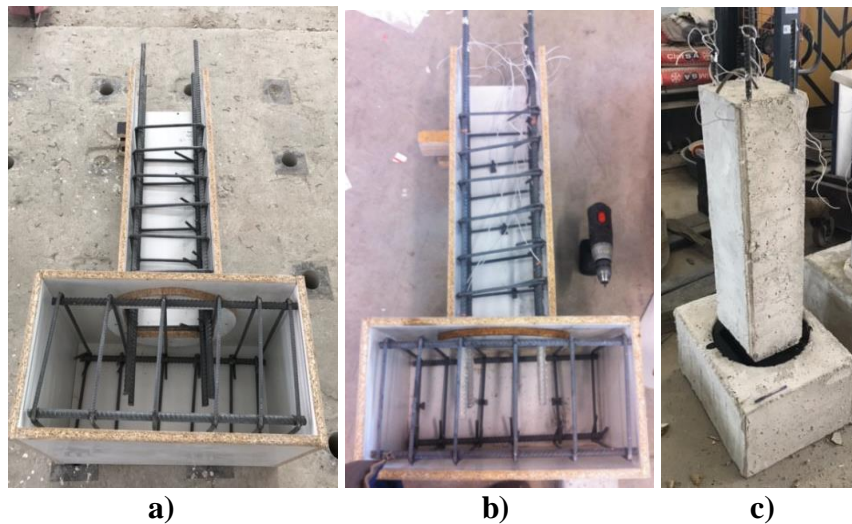
Figure 2. a) Sample mold plan, b) Insulation of sample, c) Insulation of anchor rods with epoxy resin.

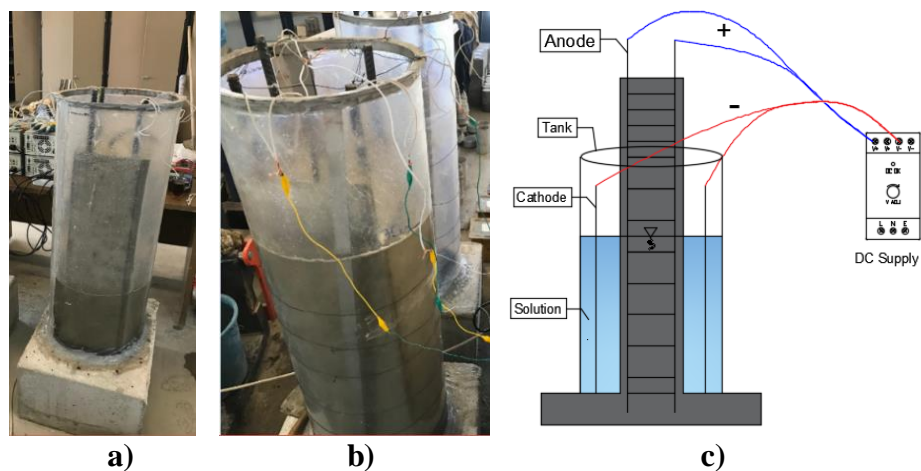
Figure 2. a) Preparing the tank and fixing it on the foundation, b) Filling with NaCl solution, c) Electrolysis cell diagram of specimen.

Electrochemical method (external current) was applied to corrode the test specimen. For this purpose, a PVC pipe with a diameter of 36 cm was fixed on the column specimens as shown in Figure 2a and a water tank was formed. This water tank was fixed on the foundation with special waterproof products. The inside of this tank was filled with a 5% NaCl solution up to 70 cm in height and an electrolysis medium was occurred (Figure 2b). The electrolysis cell diagram of the specimen subjected to accelerated corrosion testing under constant current was shown in Figure 2c. Accelerated corrosion testing was carried out for 26.5 days under constant 1 ampere current. Firstly, the weights of the reinforcements within the column specimen were weighed and their initial weights were determined before they were corroded. Then, taking into account the weights of both the longitudinal reinforcement and the stirrups in the 70 cm NaCl solution, the test time was determined before starting the corrosion test with the help of the Faraday equation. During this time, the column specimens were subjected to accelerated corrosion tests.

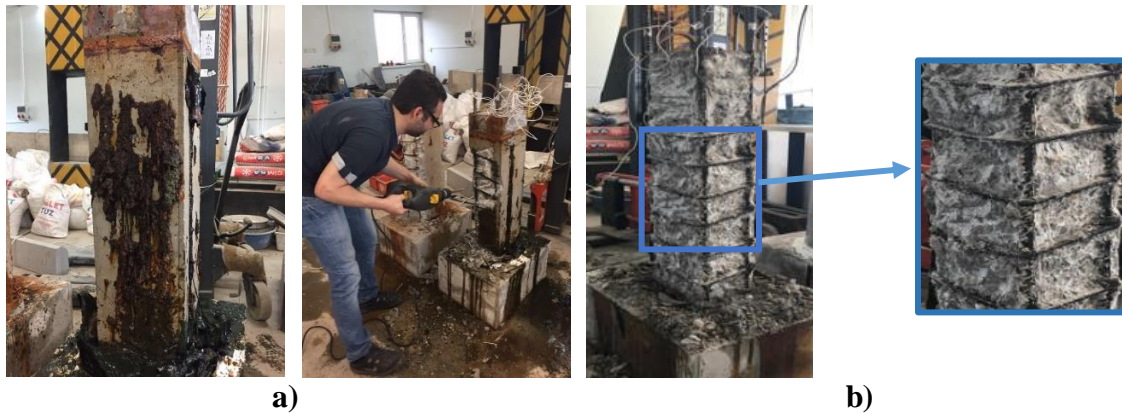
The rust formation in the column specimen and the corrosion in the reinforcements are shown in Figure 3a. In Figure 3b, column samples were broken and the distribution of corrosion on reinforcements was examined.

Figure 3. a) View of samples after the experiment, b) Peeling of concrete covers and corrosion distribution of specimen.

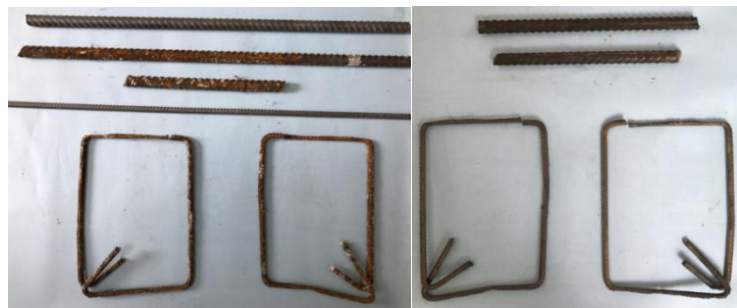
The longitudinal reinforcements and stirrups from the column specimen were first examined visually and then the rust and concrete residues on the reinforcements were cleaned with HCL acid solution. Figure 4 shows both the appearance of the reinforcements after corrosion tests and the appearance of the reinforcements cleaned with HCL acid solution.

Figure 4. View of reinforcements after accelerated corrosion test.

After 26.5 days, 663.61 gr of theoretical weight loss was expected in the reinforcements. However, after cleaning with the acid solution, a weight loss of 774.44 gr was observed. According to the results, both theoretical and actual weight losses were very close to each other. Tensile tests were performed on column longitudinal reinforcement and stirrup. The yield strength of the longitudinal reinforcement was 441 MPa and the yield strength value was obtained as 386.2 MPa after the corrosion process. Yield strength value of stirrup was obtained as 426 and 345 MPa respectively before and after corrosion.

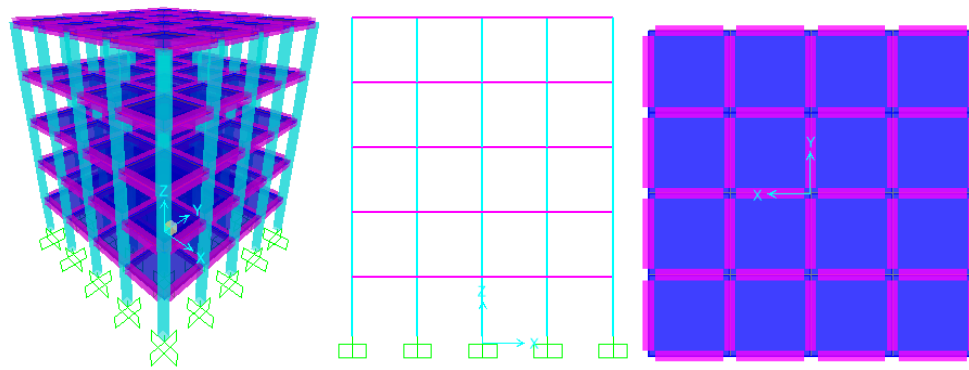
Static pushover analysis has been implemented with the help of SAP 2000 program for a sample building in Hatay province (CSI Sap, 2000). The corrosion resistance of this building is taken as reference and three different corrosion scenarios are selected in this building. These; 3 different ways of corrosion damage occurred in columns, beams and both columns and beams. For this, building modeling was done in SAP 2000 program. The example building is shown in Figure 5 and the geometric dimensions and other features of the building are summarized in Table 1.

Figure 5. Plan view of the sample building.

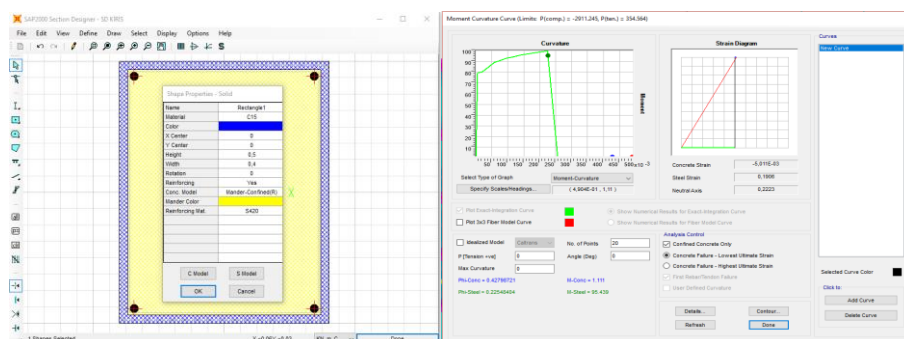
Plastic hinges are defined according to Fema-356 rules to take into account the non-linear behavior of the columns and beams, which are defined as rod elements in the SAP 2000 program (Fema-356, 2000). The effective bending stiffness of the sections were determined according to TEC-2007 and the plastic hinge lengths were entered as $L = 0.5h$ (TEC, 2007). Also, considering the confinement effects of the sections, moment-curvature relations were determined by Sap 2000 program. Figure 6 shows the properties of the sections and the relations of moment curvature.

Figure 6. Column and beam cross-sectional area and moment curvature relations of elements

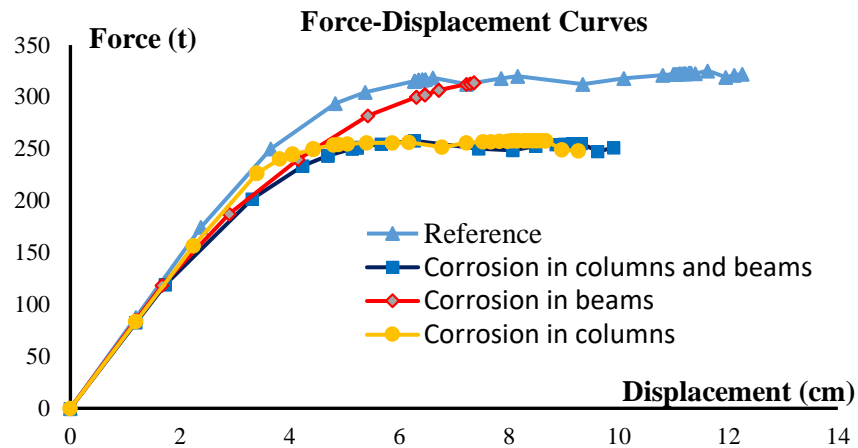
The base shear force-top displacement curves obtained as a result of the static pushover analysis performed under different corrosion scenarios in the X direction of the building are shown in Figure 7 collectively.

Figure 7. Load-displacement curves of all scenarios

When the load-displacement curves were examined, the largest base shear force was obtained from the reference scenario as 325.36t. The smallest base shear force was obtained from the column-beam corrosion damaged scenario as 255.48t with a decrease of 21.4%. When a comparison was made in terms of displacements, the maximum peak displacement was obtained as 12.26 cm in the reference building, while the smallest displacement occurred in the corrosion damaged scenario in beams of 7.36cm with a 40% decrease. Table 2 summarizes the maximum load and displacement values of the scenarios.

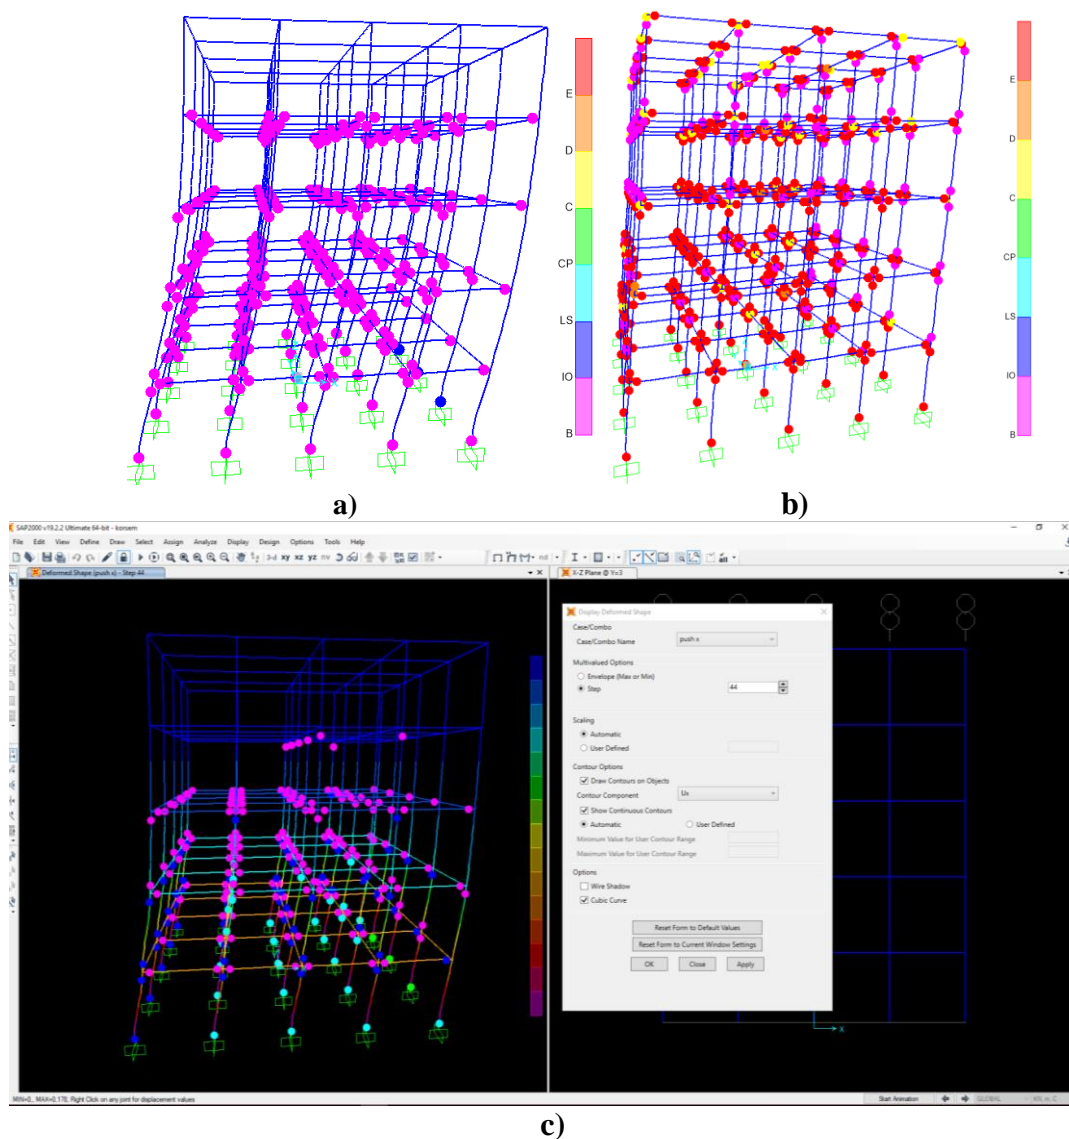
When the scenarios were examined, the corrosion damage occurred in the columns or beams changed the collapse mode of the structure. As a result of corrosion damage to the beams, the ductility of the structure decreased significantly (40%). If the damage occurred in the columns, the horizontal load bearing capacity of the structure decreased by 21%. As a result of the analyzes, it was seen that the corrosion damage occurred in the columns, the damage levels were increased by using the plastic hinges in the beams at full capacity and then the damage levels of the plastic hinges in the columns increased and the building reached its collapse position (Figure 8a). On the other hand, the consist of corrosion damage in the beams, not to the progress of the damage level of the hinges in the beams, the hinge formation jumped to the columns, and therefore the upper floor beams remained in the elastic region of the structure reached the collapse position. (Figure 8b). In the reference building, the plastic hinges were formed on the lower floors and the columns and beams on the upper floors exhibited an elastic behavior (Figure 8c).

Figure 8. a) Development of plastic hinges in beams, b) Development plastic hinge in columns, c) Hinge status in reference building.
